Mobile Intel® Celeron® Processor at 466 MHz, 433 MHz, 400 MHz, 366 MHz, 333 MHz, 300 MHz, and 266 MHz Specification Update

Release Date: August 2002

Order Number: 244444-035

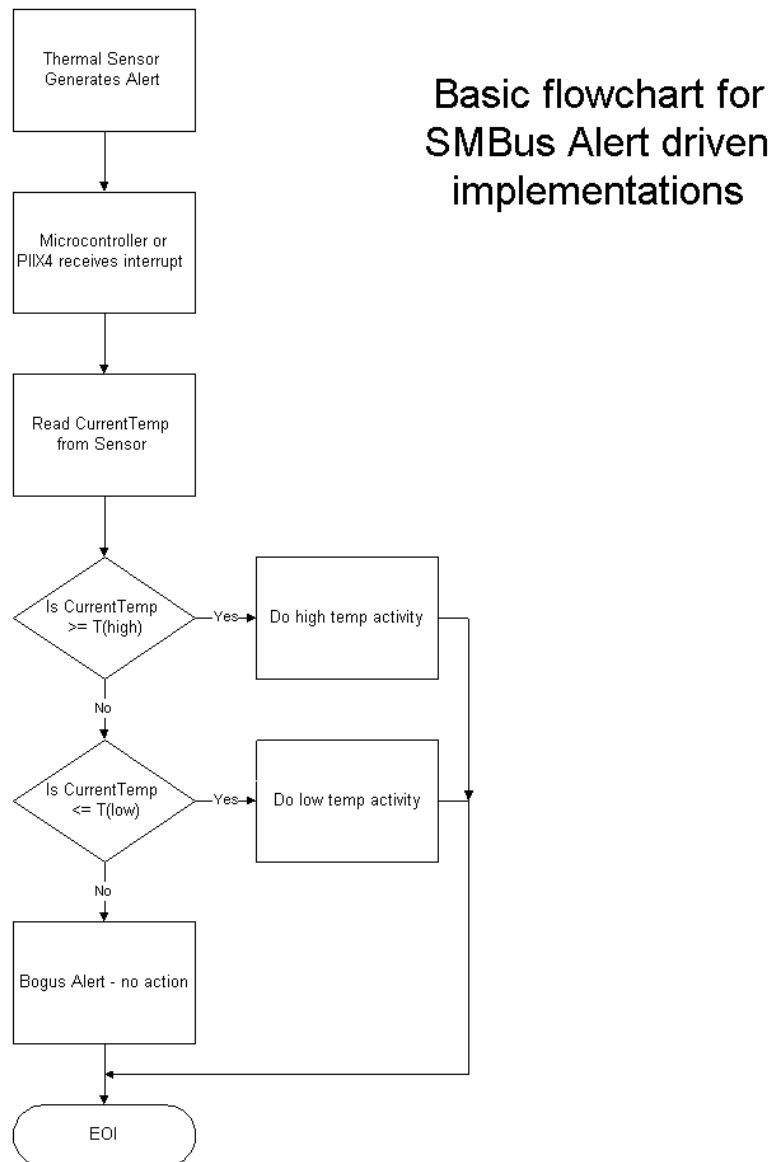
Figure 2. Workaround Flowchart: SMBALERT#-Driven System

H29. Thermal Sensor May Assert SMBALERT# Incorrectly

Problem: The Intel Celeron Processor Mobile Module has a thermal sensor that monitors the processor core's temperature. Please note that desktop systems could have a similar thermal device. The thermal sensor asserts SMBALERT# if the processor temperature exceeds the temperature limits set in the Alarm Threshold Registers (T_{HIGH} , T_{LOW}). It also sets the corresponding Status Register bits to identify the cause of the interrupt. Figure 1 gives one example of the how the SMBALERT# signal could be used in a system.

Workaround: Three different (mutually exclusive) workarounds are possible:

1. Before servicing an interrupt from the thermal sensor, read and compare the processor thermal reading with the threshold limits (T_{HIGH} or T_{LOW}). Figures 2 and 3 provide basic flowcharts for the implementation of this workaround in an interrupt driven system.
2. If the firmware implemented polls the Status Register only, then before taking any action, re-read the temperature register and do a comparison with the alarm threshold limits (T_{HIGH} or T_{LOW}) to determine if the value is actually still within the temperature window.
3. Use a temperature polling scheme to monitor the processor temperature.
